United States  
Department of  
Agriculture  
Forest Service  
Forest  
Products  
Laboratory  
Research  
Paper  
FPL 364  
March 1980

(12)  
**Fire Development and  
Wall Endurance in  
Sandwich and  
Wood-Frame Structures**

## ABSTRACT

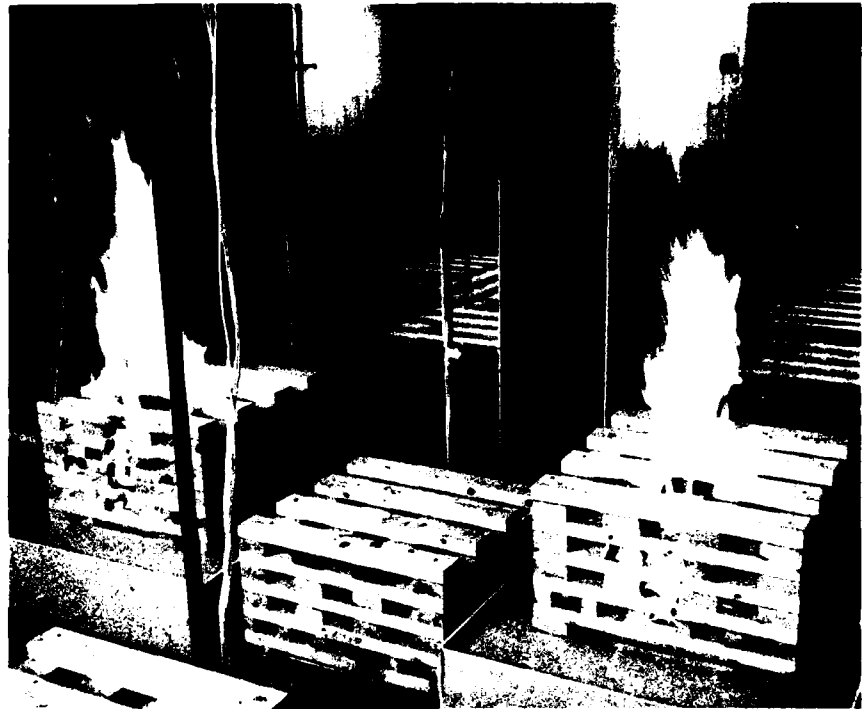
(M 143 767-4)

Figure 3.—Ignition cribs shortly after the start of the test—Structure 7. White, beaded wires are thermocouple "trees." Pipes at center of rear room and at the far left are for gas sampling.

2) (12). All material was dried to constant weight at 80° F and 30 percent relative humidity—about 6 percent moisture content. The cribs were distributed on the floor of the structure (figs. 2-3), with four triple-type cribs included to represent large furniture items.

Within 2 to 6 minutes after the two ignition cribs were ignited (fig. 3) and (table 4), flames from the cribs reached the gypsum wallboard ceiling, but did not immediately spread across the ceiling. Cribs adjacent to the ignition cribs ignited as early as 3:45 and as late as 14:40 into the test. Flames and increasing radiant flux brought on ignition of other cribs. As temperature increased, the wood decomposition products accumulated in the room. Before all cribs ignited in the large room, the flames from the individual cribs appeared to blend together and began to fill the room. These flames then usually extended or spread upward along the walls, across the ceiling, and out the east windows of the large room. The time of flame emission from the east windows was reported as the flashover time (table 4). Within 45 seconds, and usually before any cribs were ignited in the small west rooms, the flashover in the large room extended into the small rooms and out the windows at the west end of the structure.
